Stewardship Horticultural
5225 East Shawna Ln.
Reno, NV 89511
(775) 849-1215

August 28, 2023

Parkwood Condominiums
c/o Sheryl Lipari
4200 Millbrook Ln
Reno, NV 89509

Re. Landscape Health Evaluation

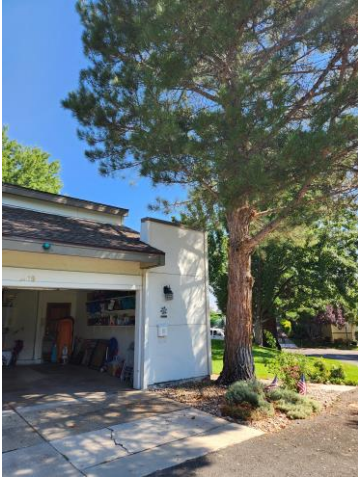
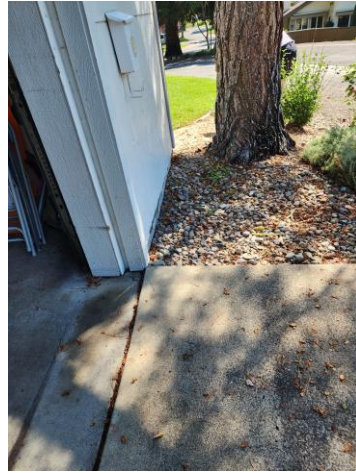
Photo 1a & b: 419 Rose Garden Ct (Pine)

There is a large pine tree that is growing in a confined space between the walkway and the garage. The tree is in fair health. No disease was noted, but it is heavily infested with Pitch Moth. The tree has lifted the walk in the past, and corrective measures were taken to reroute the walkway to give space to the pine. Unfortunately, with so little space available for the tree (the trunk is approximately one foot from the walkway, two feet from the garage, and five feet from the road) it will continue to cause structural damage to the walkway and potentially the garage foundation if the tree remains. (Photos 1a&b)

419 Rose Garden Ct (Pine): This pine will continue causing infrastructure damage as it has very little space for trunk/ rootflare growth without contacting the walk or the garage wall. It would be more cost-effective to remove the tree at this time, before it causes more damage, and to re-plant with a smaller, more appropriate species (see recommended tree planting list).

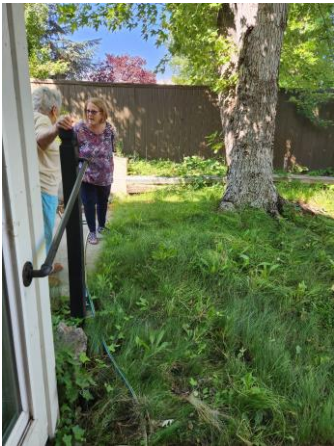
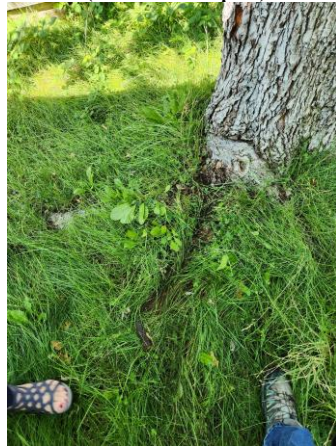
Photo 2a & b: 435 Rose Garden Ct (Silver Maple)

The homeowner is concerned that a large Silver Maple (*Acer saccharinum*) is causing damage to her foundation and causing cracks in her interior walls. She also believes that the cracks go all the way through to the exterior, and that they are hidden behind the siding. The silver maple is planted in her backyard, approximately twelve feet off the northwest corner of the condo. This is a healthy tree with a strong root-flare visible at soil level. There are no main structural roots growing directly towards her condo wall; however, a root may have branched off under the soil surface. There are no visible cracks in her foundation near this tree. (Photos 2a&b)

435 Rose Garden Ct. (Silver Maple): A foundation inspection can be done to determine if there are any cracks in the foundation and if this tree is contributing to the crack formation, or if the cracks are from settling. An inspector should look from under the house, and from the outside of the foundation (rocks and plants would need to be removed).

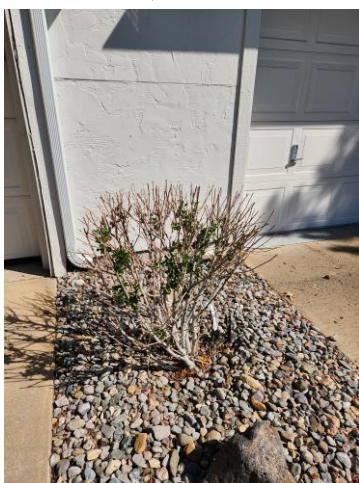
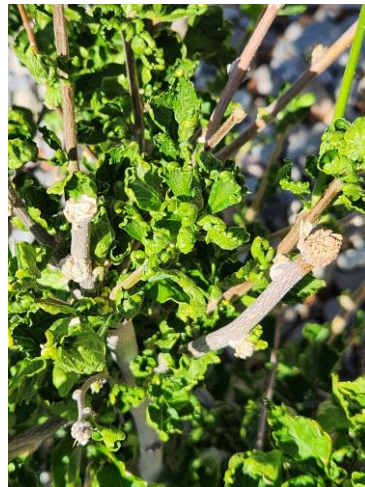
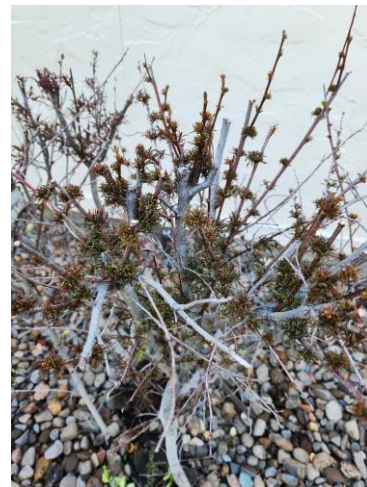
Photo 3a & b: Chemical damage at 431 & 435 Rose Garden Ct. (and 1 other location off Lorraine Ct)

While passing by I noticed that the Rose of Sharon (*Hibiscus syriacus*) have distortions to their leaves that are consistent with chemical damage. There was another plant, a barberry, in a yard by Lorraine Ct that was also showing chemical damage symptoms (Photos 3a & b)

harmed (I also saw one other plant off Lorraine ct, a sandcherry, with the same distorted leaves from chemical sensitivity).

431 and 435 Rose Garden Ct. (Rose of Sharon): I would question the homeowners and the landscape maintenance people to find out what chemical has been applied near these plants. It is most likely that this is inadvertent toxicity; whomever is responsible, they should be aware that the shrubs are being

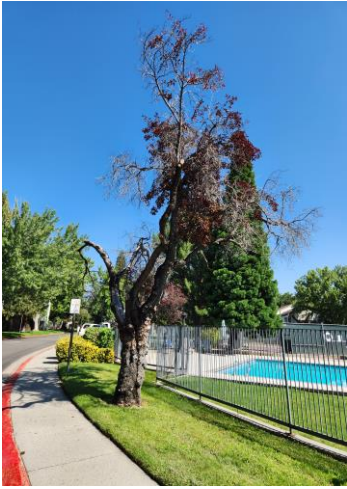
Photo 4: Pool Area (Purple plums):

There are two purple plums (*Prunus cerasifera*) growing in the lawn between the pool fence and road. The northwestern tree is in a state of severe decline from past injuries, limb loss and crown gall bacterium (likely introduced on dirty pruning equipment). The more southern tree is also in poor health but has more live tissue than the second tree. (Photo 4)

Pool Area (Purple plums): The northwestern tree should be removed. It is in severe decline and likely will never look better than it does right now. The Southern tree is in a state of decline as well, but it is not in as poor health. This tree could be replaced now, or it could be left for a few years and replaced later (Please see recommended tree species list for your complex).

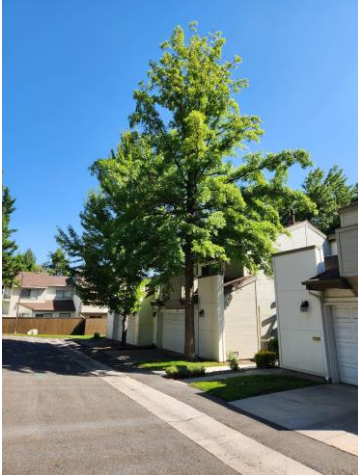
Photo 5: 4154 Marigene Ct. (Pin Oak):

There is a large Pin Oak (*Quercus palustris*) growing in a small space between the walkway and the condo. The tree is only about a foot away from the garage wall. It is suspected that this tree may be causing damage to the plumbing and clogging the pipes coming into the condo, and work is already scheduled to dig up the area. (Photo 5)

4154 Marigene Ct. (Pin Oak): This is a healthy tree that does not appear to be causing structural damage to the house or hardscape at this time. I do not recommend removing this tree. When the sewer/ waterline is dug up, a chemical impregnated root barrier fabric can be laid around the new piping to prevent future root intrusion into and around the pipe. It is important to note that the tree roots generally do not 'break into' pipes or cause cracks in foundations, they take advantage of existing cracks and grow through them, exacerbating the problem).

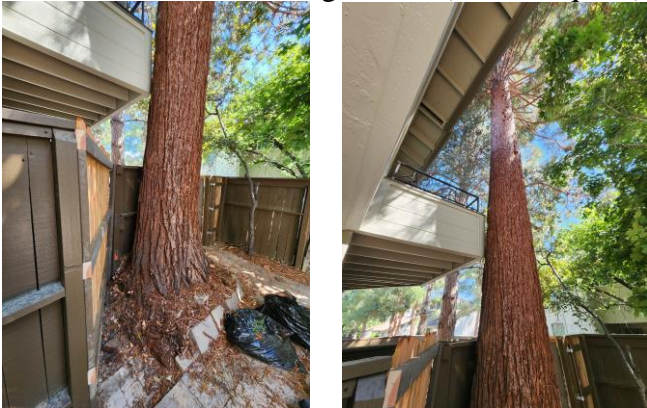
Photo 6a & b: 4006 Bluegrass Ct. (Giant Sequoia):

There is a large, immature Giant Sequoia (*Sequoia sempervirens*) growing off the back patio on the east side of the residence. The tree's trunk is growing only a few inches from the upstairs balcony. The tree has been 'limbed up' approximately 25 feet; its canopy is not directly visible from the residence. (Photos 6a&b)

4006 Bluegrass Ct. (Giant Sequoia): Unfortunately, this is a tree species that never should have been planted in such a small space and so close to the building. Giant sequoias can grow to one-hundred or more feet tall in urban areas, with trunk diameters over ten feet wide. They are a moderate to fast growing species. This sequoia is only inches away from the upstairs deck; it likely will start causing infrastructure damage to the deck within the next five years or so. As much as I hate recommending that any healthy tree be removed, this is one exception. It is not a matter of IF this tree will cause problems to the building, it is when. Considering that the tree has been limbed up to roof level, and the surrounding tree canopies are providing screening and shade for the building, the removal of this tree should not greatly change the ambiance of this home.

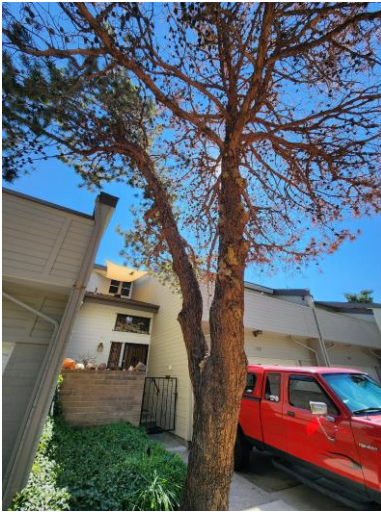
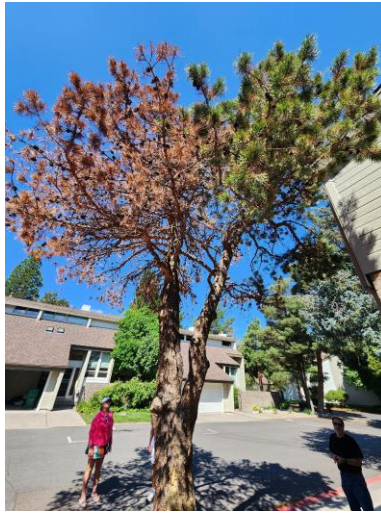
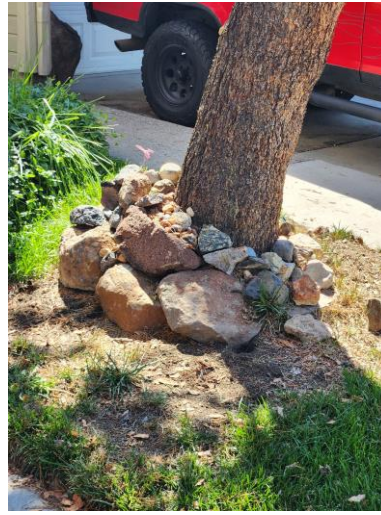
Photo 7a b & c 4008 Ruth Ct (Pine)

Double leader pine tree in front of residence: The larger, south side leader, is dead, the north side leader is in declining health. This tree has been significantly 'limbed up' in the past, likely contributing to its decline. The rootflare is not visible, as rocks are built up around the trunk, which might also be contributing to the tree's decline. (Photo 7 a b & c)

4008 Ruth Ct. (Pine): This double leader pine is in severe decline. Pruning out the dead wood is an option, but with the amount of deadwood in this tree, it is unlikely that the remaining leader has enough needles to support the tree (the needles produce energy for the tree through photosynthesis; when too many branches are removed (or die) at one time, it is a stress to the tree. Root death often occurs after branch loss, as there isn't the same food source to support the tree). It is for this reason that I recommend removing this tree and replanting with an appropriately sized small tree/ large shrub.
